EVALUATION OF A DEWATERING SYSTEM FOR
HASTY FUEL STORAGE RESERVOIRS

Joe Medrano

October 1972

Report 2040

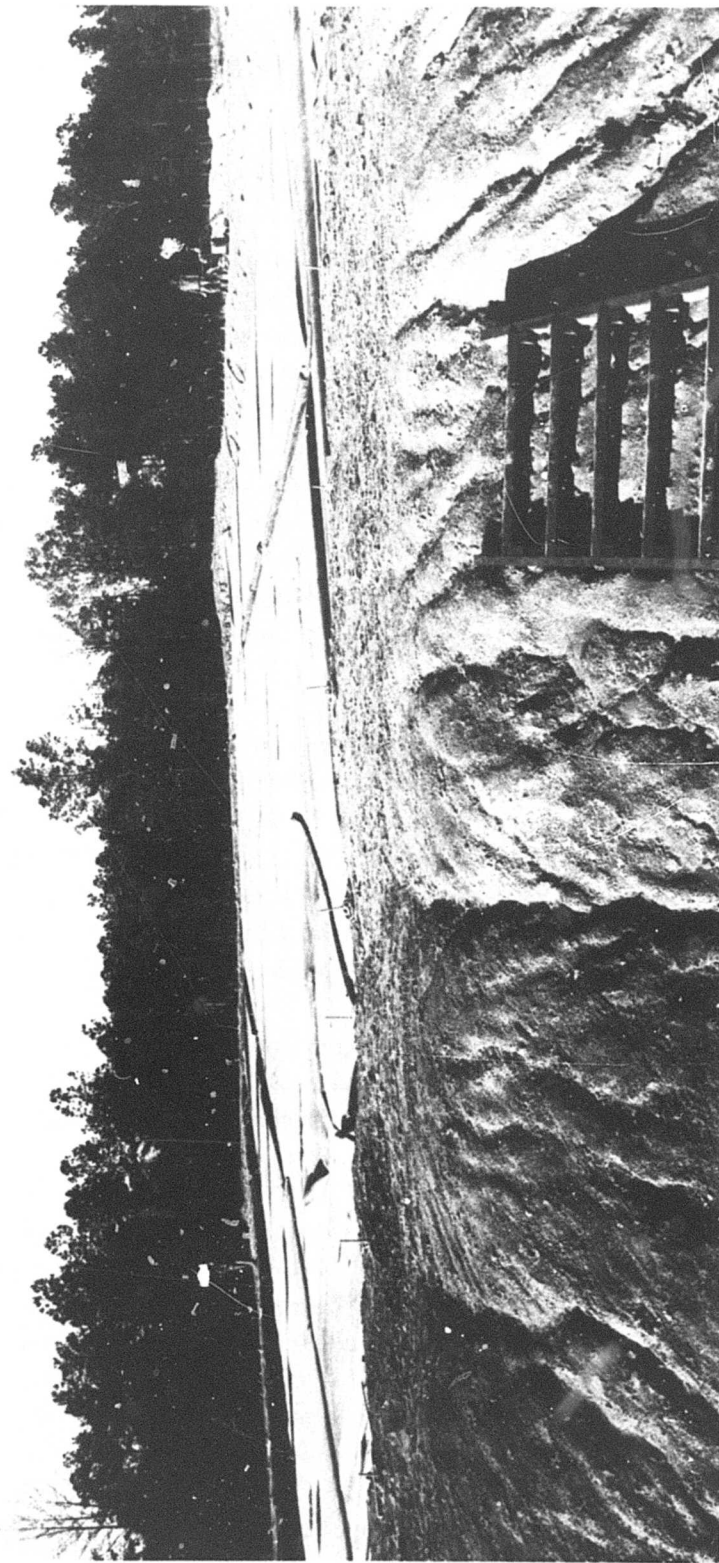
Fig. 1. A 25,000-bbl hasty fuel storage reservoir installation with dewatering system.

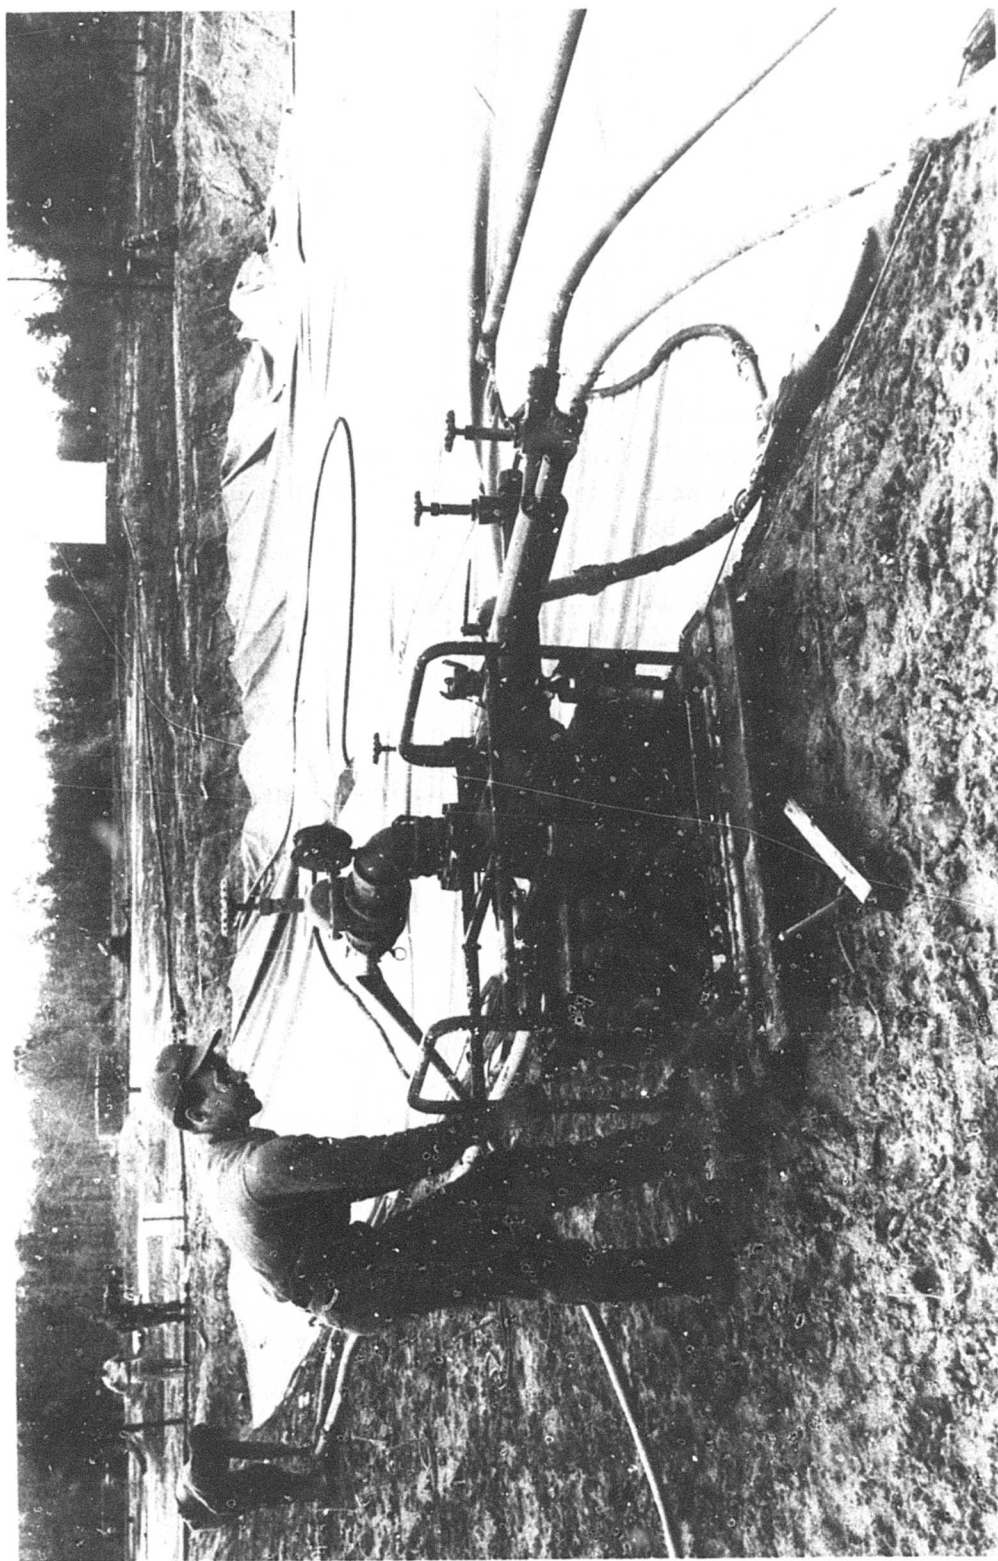
Fig. 2. Pump, manifold and hose arrangement for dewatering system during ET/ST.

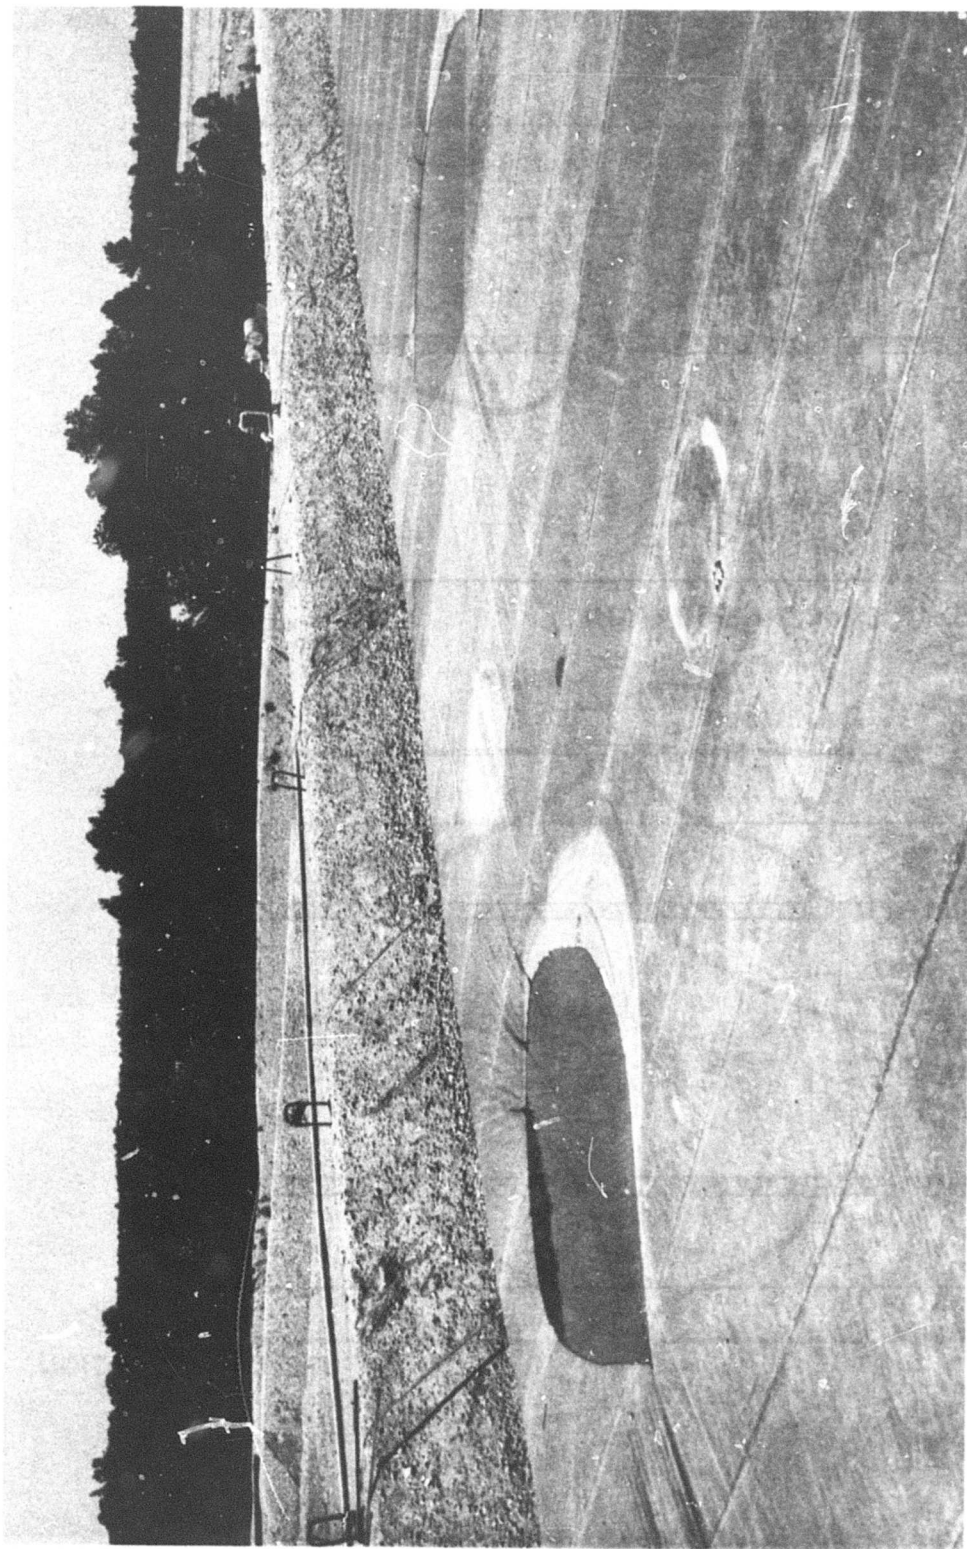
Fig. 3. Typical rainwater pool formation on top of tank surface.

2. Objective. The objective was to evaluate the suitability of the dewatering system by using a single and a double dewatering tube to remove accumulations of simulated rainfall from the top surface of hasty fuel storage reservoirs (Fig. 3).

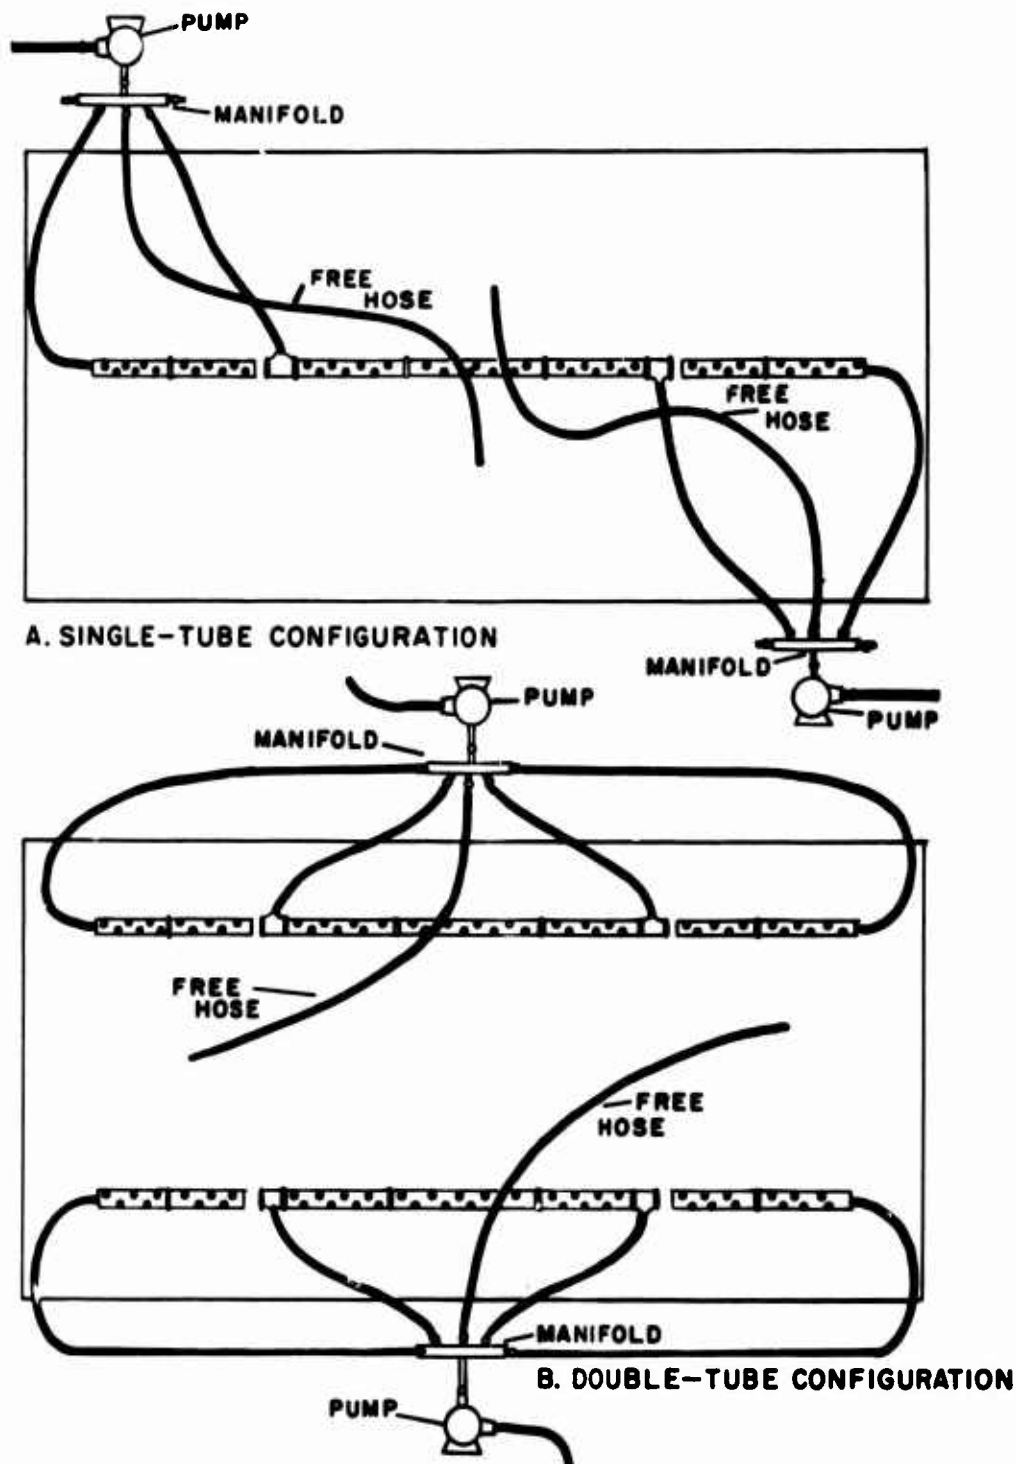
Fig. 4. Dewatering system test configurations.

The dewatering equipment was positioned in two different configurations as shown on Fig. 4. Each pump was attached using a 4-inch manifold to either three or five 2-inch suction hoses, depending upon the tube configuration utilized. One of the suction hoses was designated as a "free" hose and was not attached to the dewatering tube. The "free" hose was positioned by use of ropes and was used to dewater pools which were not accessible to the dewatering tubes.

a. Evaluation of Single Dewatering Tube with Reservoir at One-Third of Capacity. One dewatering tube and two pumps were positioned as shown on Fig. 4A, and the reservoir was filled with approximately 8000 barrels of fuel. The rainfall simulation system was operated for a period of 20 minutes.

c. Evaluation of Double Dewatering Tubes with Reservoir at One-Third of Capacity. The reservoir was completely emptied of fuel and a second set of dewatering tubes was installed. Both sets of tubes were positioned as shown on Fig. 4B. The reservoir was then filled with approximately 8000 barrels of fuel (Fig. 5). The rainfall simulation system was operated for a period of 30 minutes.

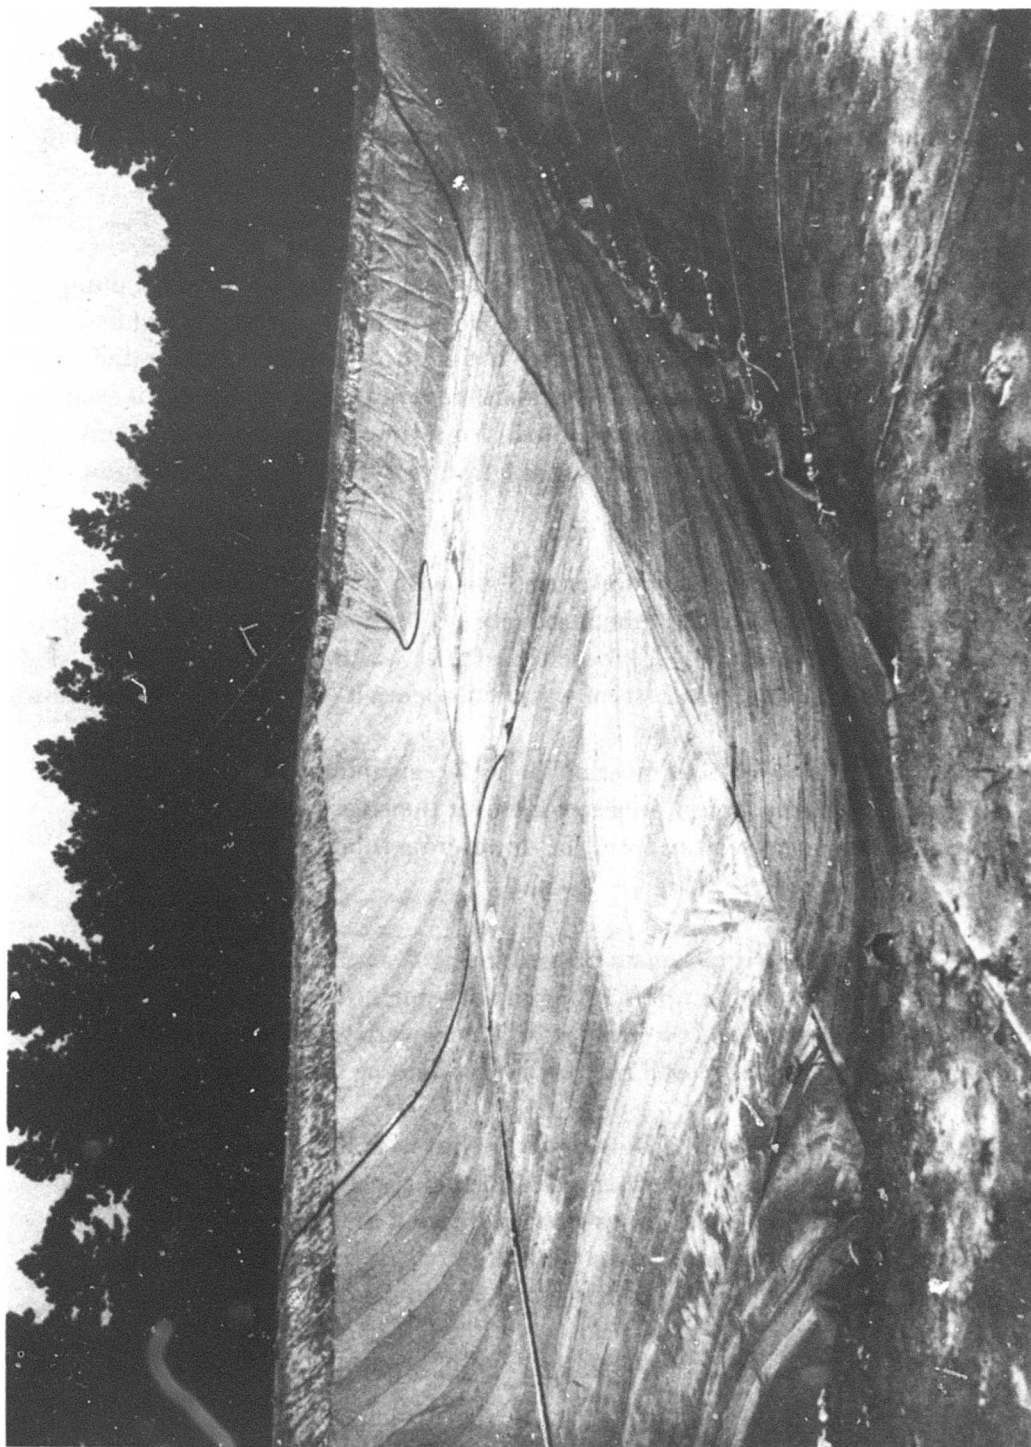
Fig. 5. Double dewatering tubes on reservoir filled to approximately one-third capacity.

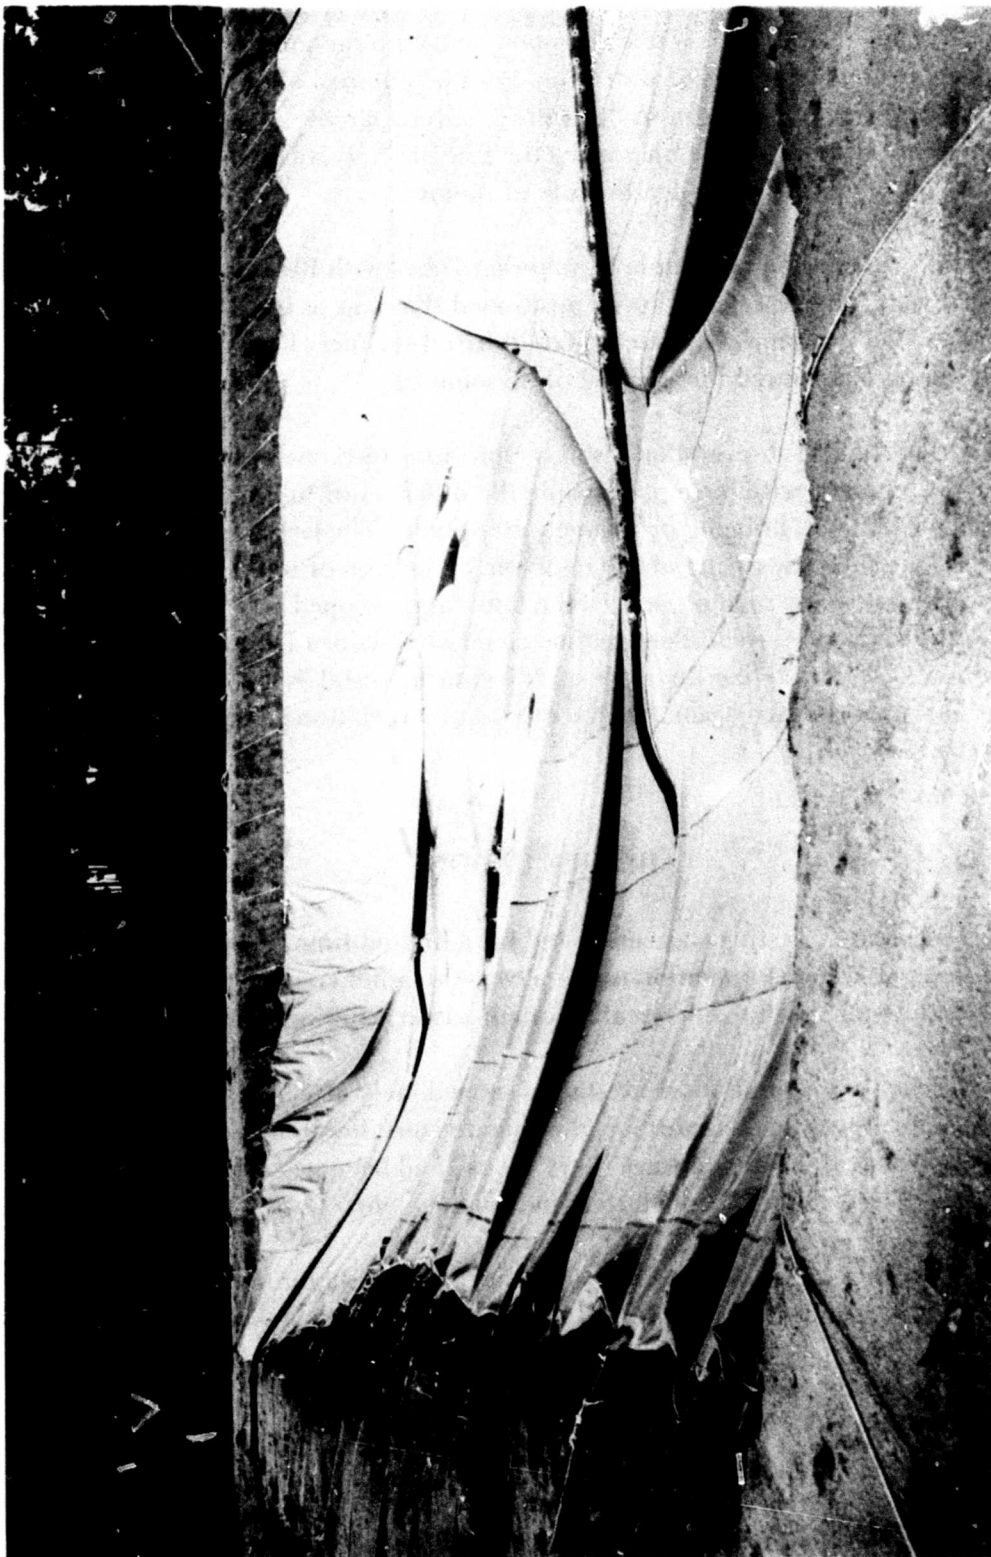
Fig. 6. Dewatering tube bridging over pool of water.

surface of the tank. Both dewatering tubes shifted position and became misaligned during dewatering operation as water from one pool emptied into a larger pool. One set of tubes bridged over pools of water could not be pumped using the dewatering tubes (Fig. 6). Some pools began to "tear drop" after a large volume of water had collected and could be pumped off only using the free hose. It was noted that the rate of rainfall simulation greatly exceeded the rate of removal.

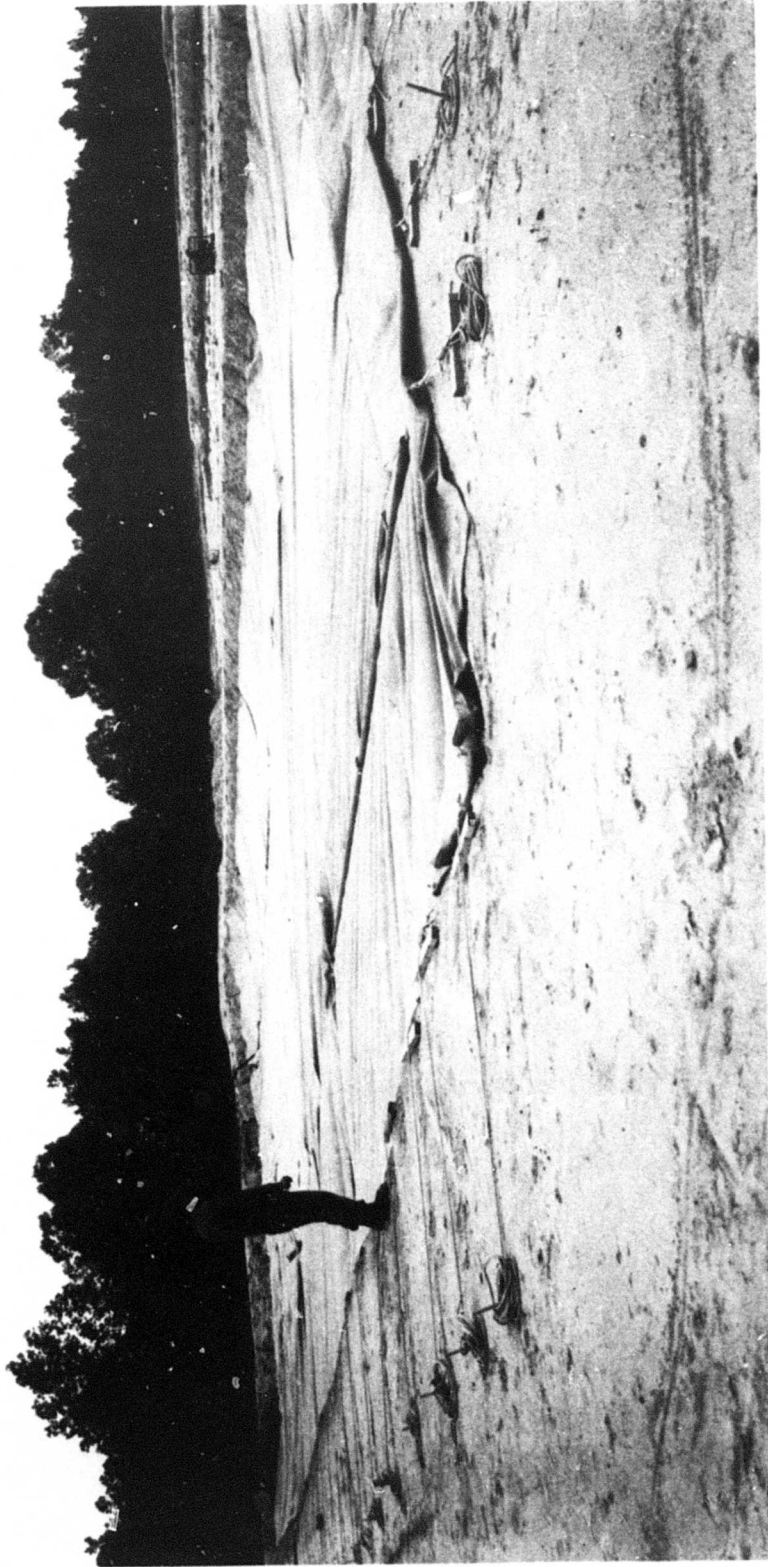
Fig. 7. Dewatering tubes on reservoir filled less than full capacity.

d. Evaluation of Double Dewatering Tubes with Reservoir at Two-Thirds of Capacity. With the dewatering tubes positioned the same as in the previous test, the reservoir was filled with approximately 16,000 barrels of fuel (Fig. 7). The rainfall simulation system was operated for a period of 25 minutes.

The test showed that, as in the previous test, one set of tubes became completely submerged with large pools while the other set of tubes remained on the top surface of the tank, bridging over large water pools. The largest pools were noted directly over the fill-draw fitting of the reservoir. A section of tubes was misaligned during the operation and in another area the tank fabric slipped over the tube but no damage to the tank was noted. Pump prime could be obtained from one tube through only two hoses. A dewatering flow rate of 180 gpm was established during the dewatering operation. It was noted again that the rate of accumulation greatly exceeded the rate of water removal.

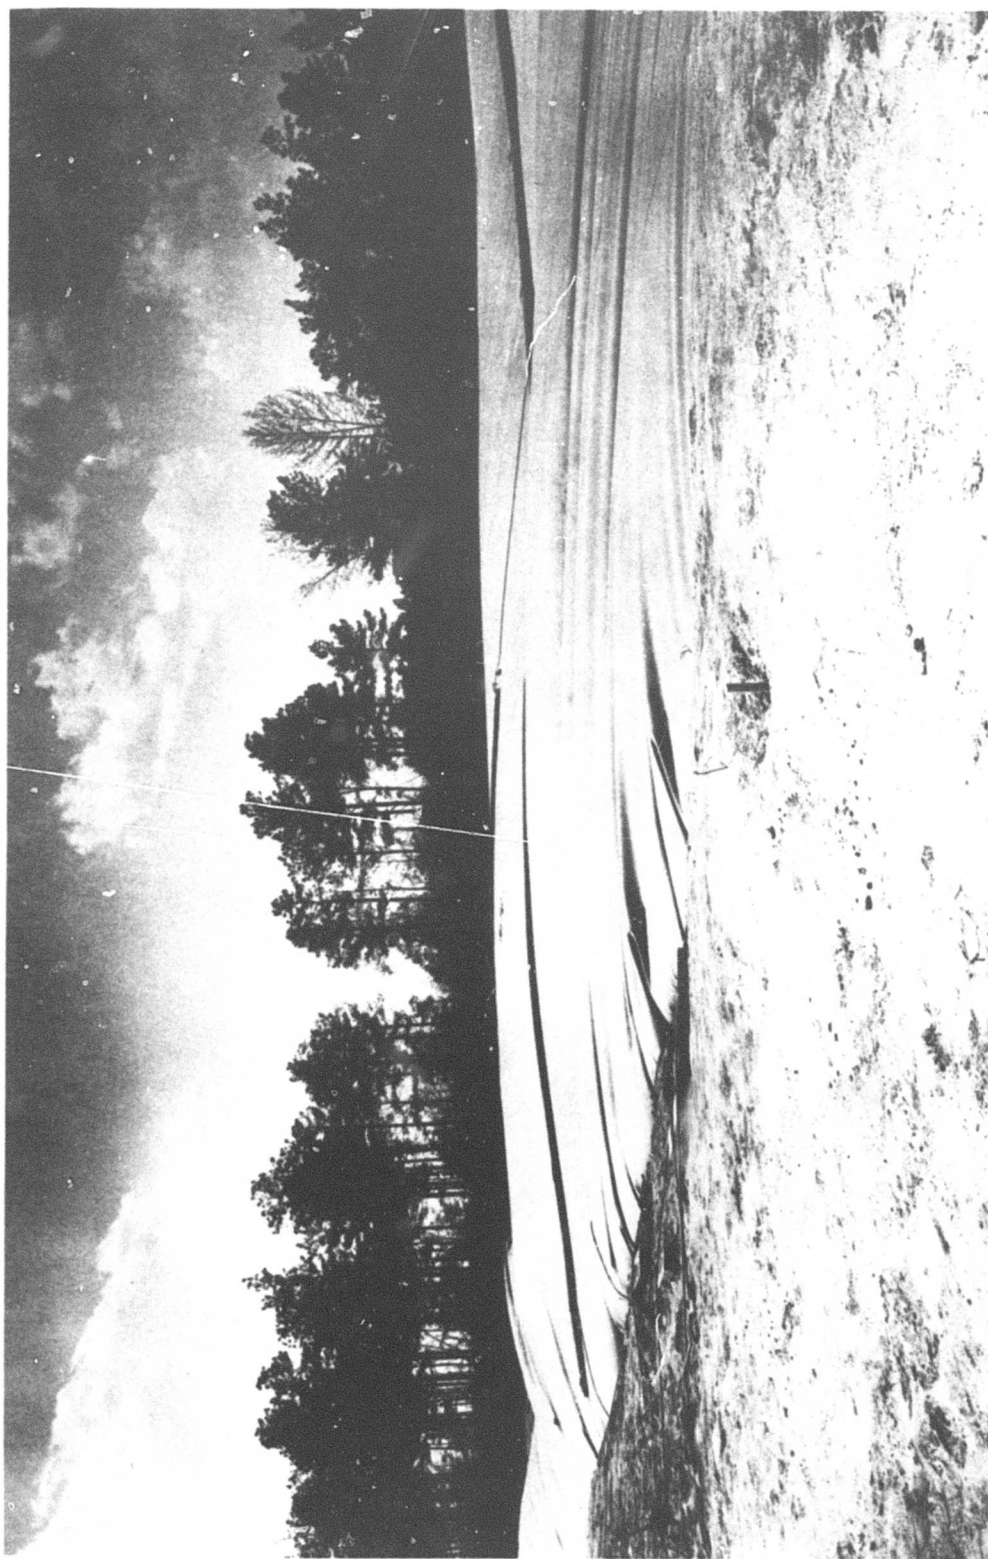
Fig. 8. Dewatering tubes on tank with gasoline vapor pockets.

vapor between the tank fabric and the top surface of the contained fuel (Fig. 8). The vapor pockets caused the tank fabric to float and, as a result, displaced the dewatering tubes, causing misalignment. The vapor pockets also caused the water to pool in depressions formed in fabric folds, which was the start of a large pool.

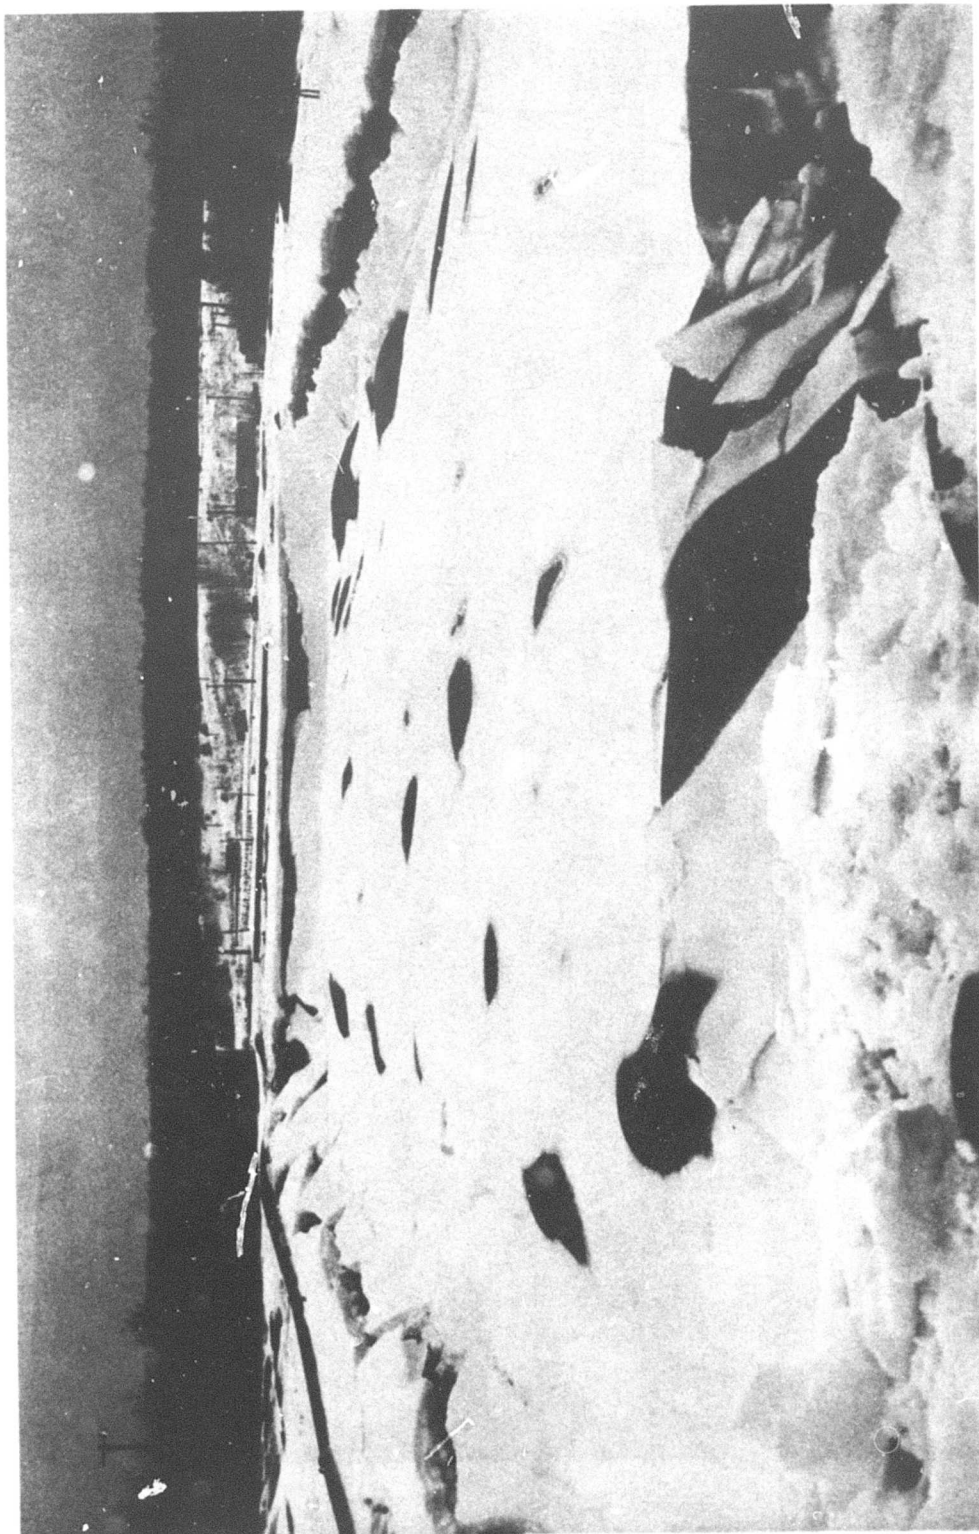
Fig. 9. Accumulations of snow on the top surface of a hasty fuel storage reservoir.

The dewatering system was not tested during winter conditions. Previous experience with hasty storage reservoir operations during freezing weather has shown that snow accumulations on the top surface of the reservoir interfere with dewatering operations. Accumulations of snow slid down the walls into the pit and piled up on the top surface of the tank (Fig. 9). Accumulations of snow in the area of the fill-draw fitting prevented withdrawal of fuel from the reservoir.

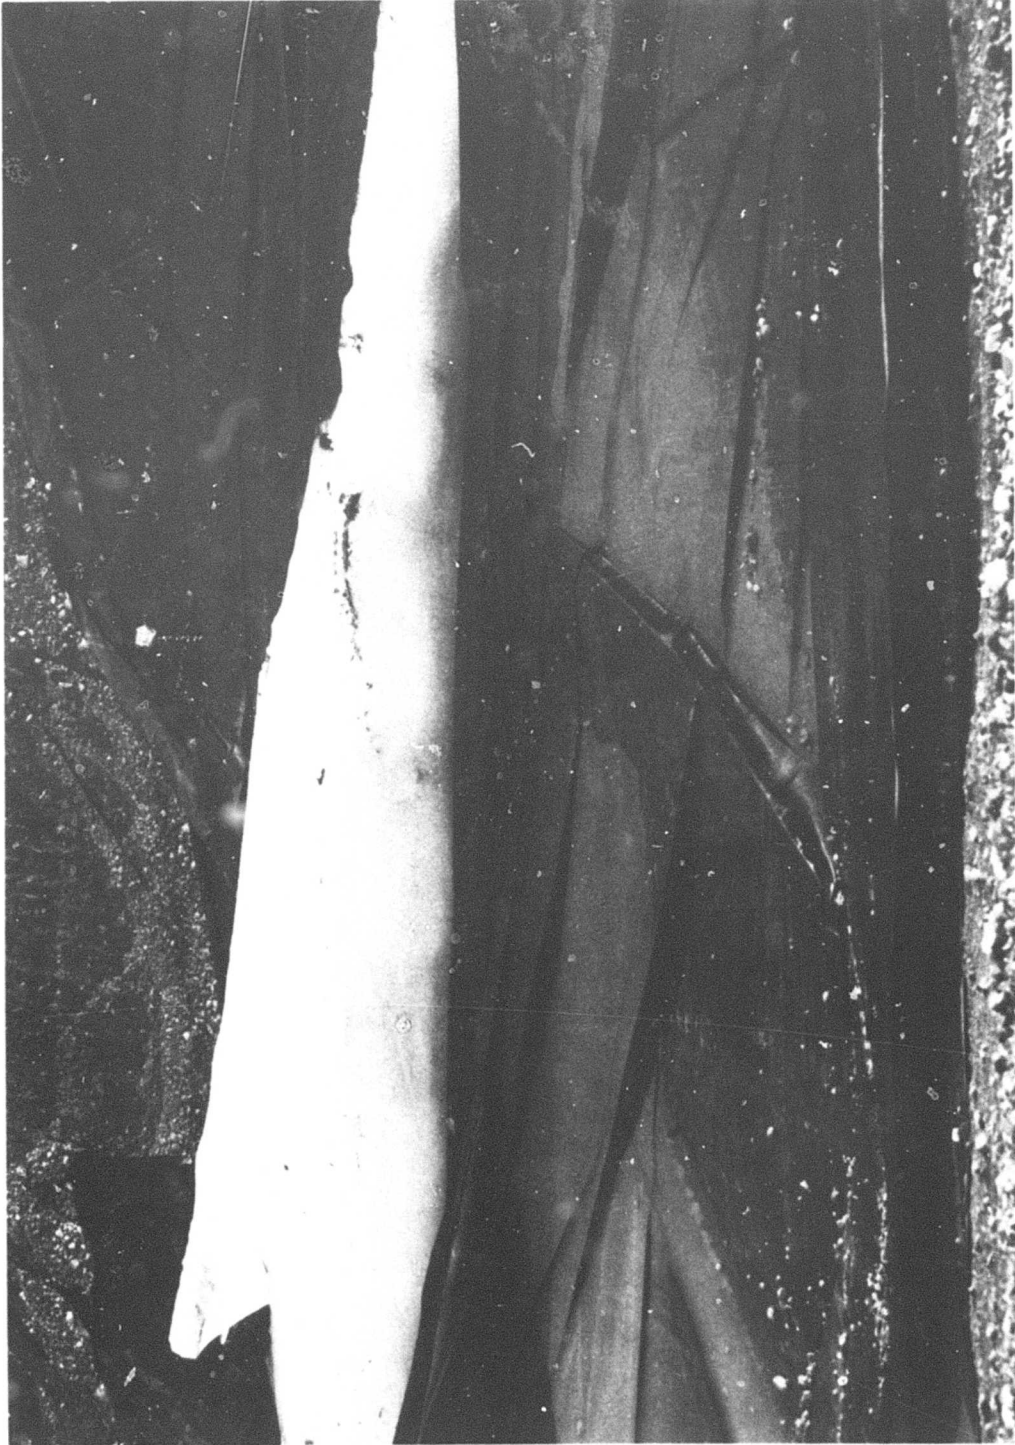
Fig. 10. Ice formation from water pool on the top surface of a hasty fuel storage reservoir.

When the snow melted, a different problem existed. When the temperature was above freezing, the melted snow formed pools of water that could be pumped off using the dewatering system. During freezing temperatures, the pools of water froze (Fig. 10). Ice formation over the tank surface near the fill-draw fitting prevented fuel from being withdrawn from the reservoir. The tank fabric was also susceptible to puncture by sharp protruding edges of the ice formation, especially when the ice sheets broke up. The dewatering system is incapable of removing any amount of snow accumulation or ice formation from the top surface of the reservoir.
